NATIONAL DAM SAFETY PROGRAM. ELM CREEK DAM (DAM NUMBER 16), (IN--ETC(U)

REPORT DOCUMENTATION PAGE		READ INSTRUCTIONS BEFORE COMPLETING FORM
1. REPORT NUMBER	2. GOVT ACCESSION NO.	3. RECIPIENT'S CATALOG NUMBER
	41-101	84
4. TITLE (and Subtitle) Phase I Inspection-Report Elm Creek Dam Allegheny River Basin, Cattaraugus County, NY Inventory No. 593		5. TYPE OF REPORT & PERIOD COVERED Phase I Inspection Report National Dam Safety Program

17. DISTRIBUTION STATEMENT (of the abstract entered in Block 20, if different from Report) (6) National Dam Safety Program. Elm Creek Dam (Dam Number 16), (Inventory Number N.Y. 593), Conewango Creek Watershed, Allegheny River Basin, Cattaraugus County, New York. Phase I Inspection Report,

Elm Creek Dam (Dam No. 16)

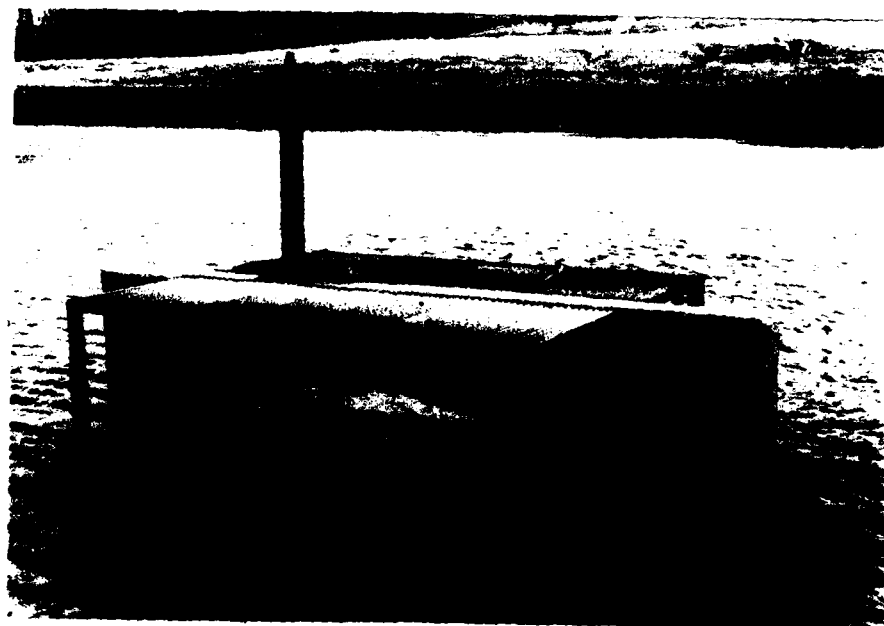
The structure is in good condition, with only a minor amount of debris on the trash rack.

2. Principal spillway high stage inlet structure showing trash rack
